Mobile Intel® Pentium® 4 Processor-M

Specification Update

June 2004

Document Number: 250721-024

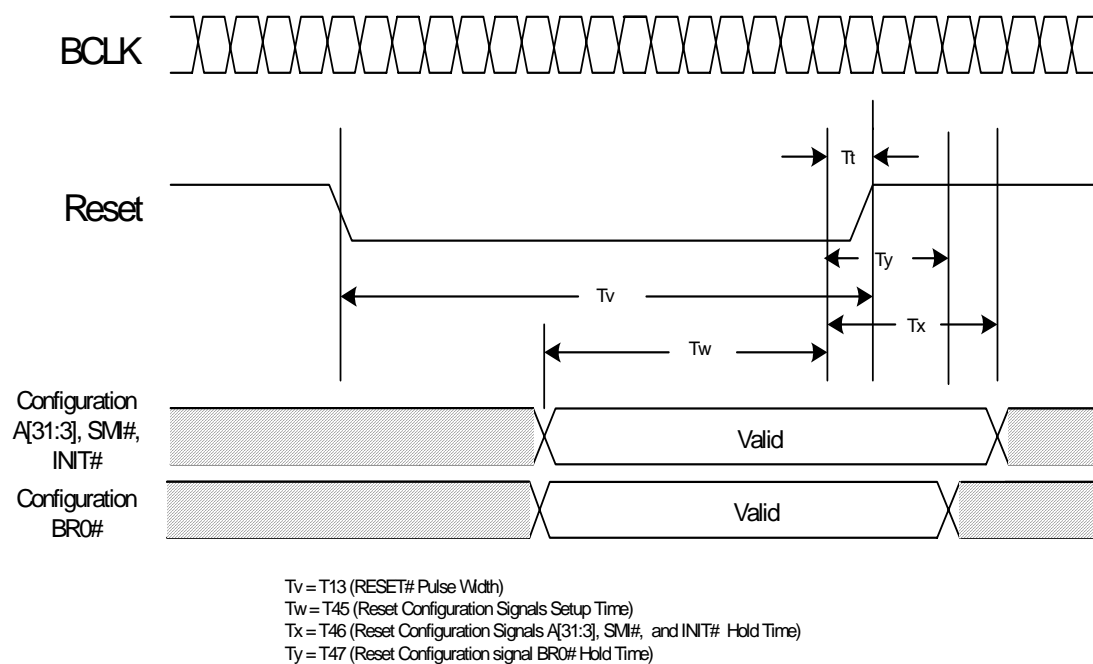
Figure 2. System Bus Reset and Configuration Timings

The BR0# maximum hold time has changed to 2 BCLKs. This change will be shown in the “System Bus AC Specifications (Reset Conditions)” table and “System Bus Reset and Configuration Timings” figure of the *Mobile Intel® Pentium® 4 Processor - M Datasheet*. This change will be incorporated in the next revision of the datasheet.

The following figure will be modified to reflect this change:
